**Canadian Society of Civil Engineers.**

**EFFECTS OF ENGINEERING WORKS ON WATER CURRENTS.**

By CYRUS CARROLL, C.E., M.CAN.SOC.C.E.

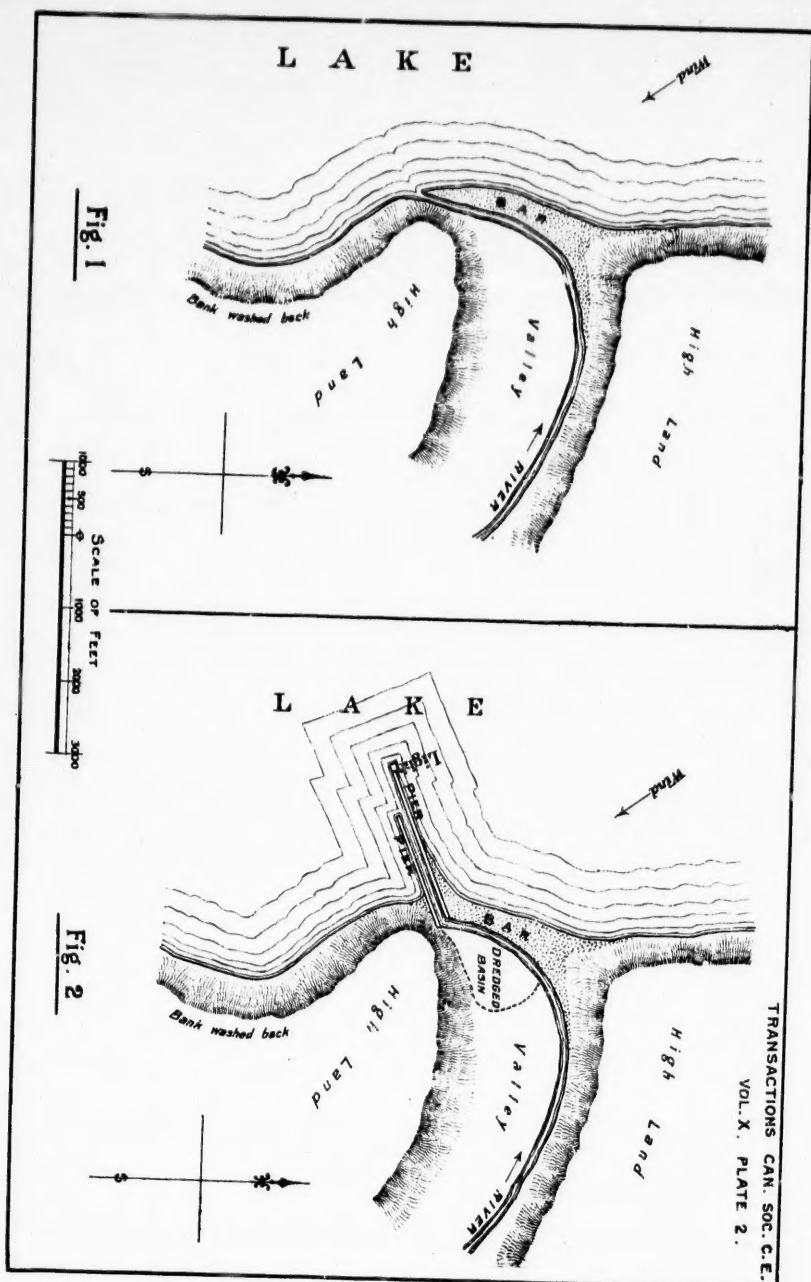
TRANSACTIONS CAN. SOC. C. E.  
VOL. X. PLATE 2.

In Fig. 1, (Plate II), we have a very fair illustration of the mouths of the Rivers Saugeen, North Sables, Penetangore, Pine River, Maitland,

Bayfield, South Sables and other rivers. By turning the same diagram as indicated by the dotted north point, it fairly represents Kettle Creek, Big Otter Creek, Little Otter Creek, Catfish Creek, and other rivers and streams flowing into Lake Erie. Long Point too bears down the lake.

It will be noticed that sand bars are formed across the ends of the river valleys, as the results of the opposing currents of rivers and lakes meeting, sometimes fairly and squarely, but generally at an angle, when they coalesce and form one current, the direction of which is determined by their relative forces after the manner of the polygon of forces.

These sand bars begin at the windward side of the valley, and extend quite across, being crowded out into the lake water at the end, by the river current prevailing over the lake current at that point. The river too is crowded against its leeward bank, which is often very steep from being washed away at the base. As a result of such crowding of bar and river, the channel is often narrow and deep where it passes the bar. The bar or bank on the windward side is strengthened and re-enforced by the wash of lake silt up against it. On the river side of the basin the bar is strengthened by the silt of the river constantly being deposited. The river bank, or rather the lake bank, on the leeward side is generally washed away. This is particularly noticeable at Port Burwell and Port Stanley, where large areas of high table land have been washed away within the last 50 years.

In Fig. 2 (Plate II) we see how some of these basins have been made to answer as harbours, after a fashion, as they could not always be entered during storms, though, as a general rule, any vessel making the lee side of the longer pier could in the stiller water move along into the harbour, or tie up to the pier. In case of very rough weather on Lakes Huron and Erie, vessels make for the large rivers at either end of such lakes, or seek the shelter of an island if near to one. Failing these, they anchor and endeavour to ride out the gale.

It is here submitted that the plan, Fig. 2 (Plate II), is the best that can be adopted in utilizing at a moderate cost the mouths of rivers entering lakes. Where such works have not proved sufficient, it would be much the best and cheapest way to continue such works out into deeper water.

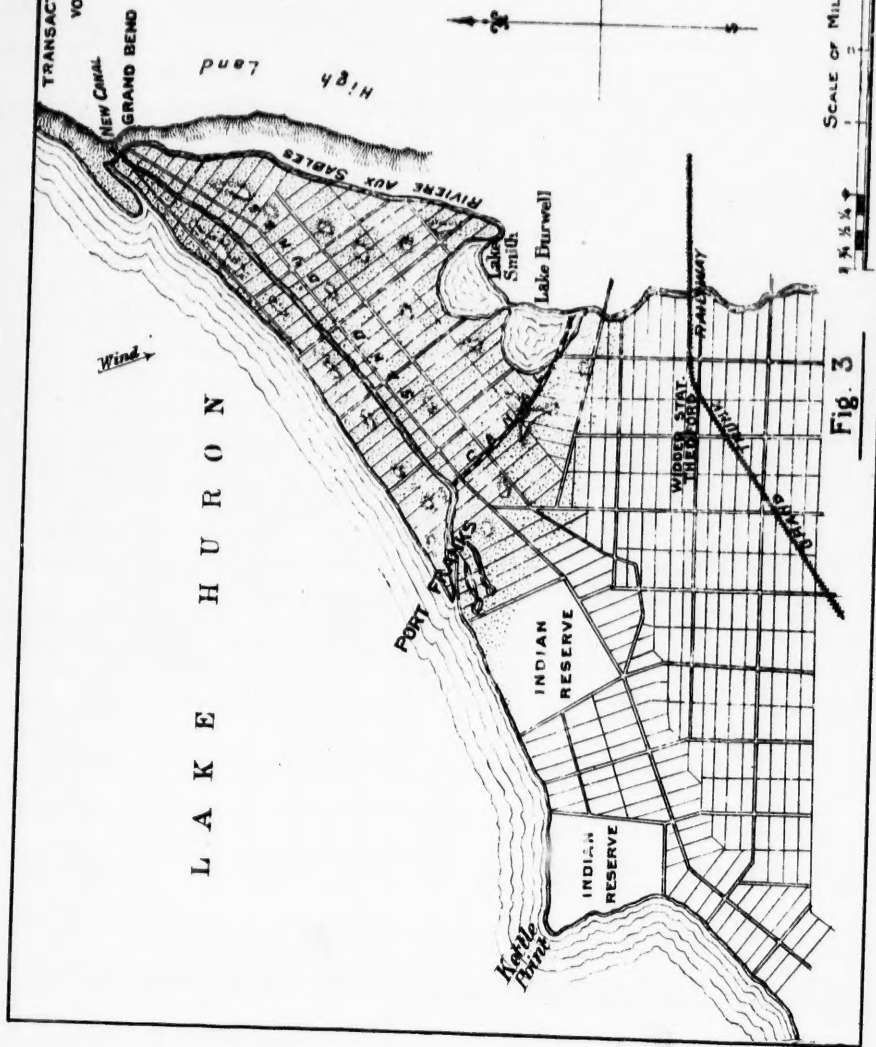
In no case is it advisable to close up the old channel and form a new one by cutting through the bar or beach. In Fig. 3 (Plate III) we have an illustration of the effects of changing the channel of a river.

In the sketch Fig. 3 (Plate III) it will be noticed there are a few sections of old channel not yet filled up. The river must have been obstructed here at different times from natural causes—new mouths made and old ones closed.

in course of time, and in the end, the flow of water has now made a channel out to the lake 100 to 200 yards in width. As might have been expected, a beach or bar at once began to form across the mouth of the canal from its north side. This is rapidly extending southerly, and carrying the channel along the base of the old dunes, on the line that was the margin of Lake Huron previous to the building of this canal, with the beach between the channel and the lake almost parallel to the old channel of the river.

The *regimen*\* of the river has been completely destroyed. No works of a permanent nature can be made at the lake shore or along the river. The damage resulting is not easy to compute in dollars and cents. Every year, and up to the present time, every freshet brings down a lot of sand for the river to work through and out of as it may. The narrowest part of the canal is 60 feet, its widest  $\frac{1}{4}$  of a mile, and this through and amongst the highest of the dunes. Lake Burwell is nearly dry every summer. Lake Smith covers two-thirds of its former area.

From the Grand Bend, the old channel, deprived of its current and of carrying the water out of Lakes Burwell and Smith, filled up for a very considerable part of the distance between Grand Bend and Port Franks—on this portion so filled, the sands are heaped up so that no trace of the former channel is visible. The lands near Grand Bend became worse flooded with water than before.
